# MULTI-USE GAMES AREAS (MUGAs)

## 2023/24 CONDITION INSPECTIONS

**VERSION:** 1.4  
**WRITTEN BY:** Neil Yates  
**IMPLEMENTED:** 13<sup>th</sup> Dec 2023

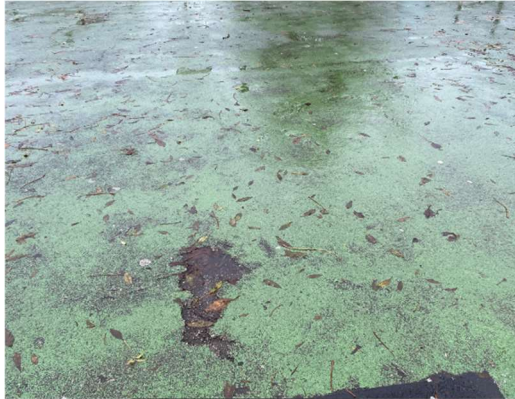
BBCMU01 – Abel Street

MUGA surface in poor condition

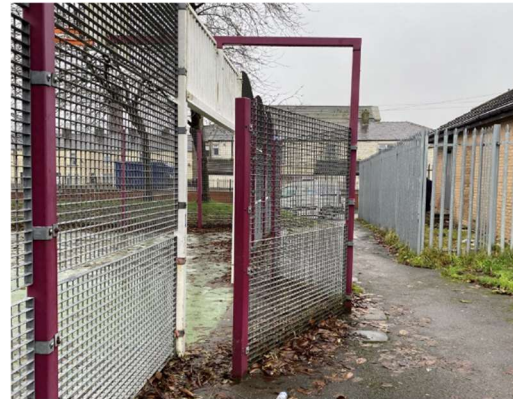
BBCMU01 – Abel Street

Narrow entrance restricts disabled access

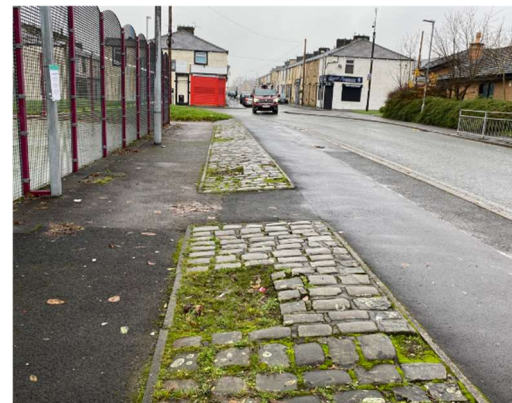
BBCMU01 – Abel Street

Voids at former tree pits/missing setts

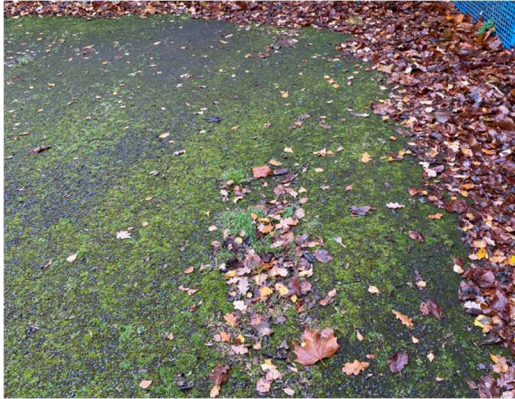
BBCMU02 – Barden Gardens

MUGA surface in poor condition

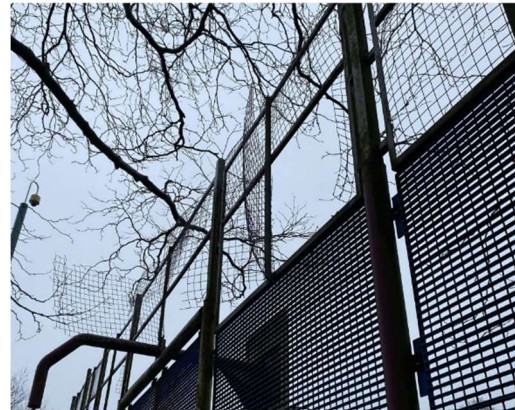
BBCMU02 – Barden Gardens

Damaged fence panels

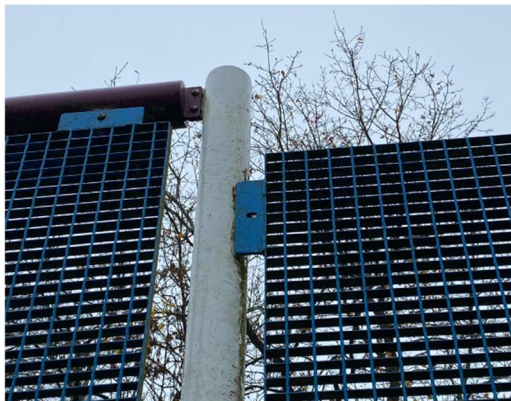
BBCMU02 – Barden Gardens

Bolt missing from fence panel

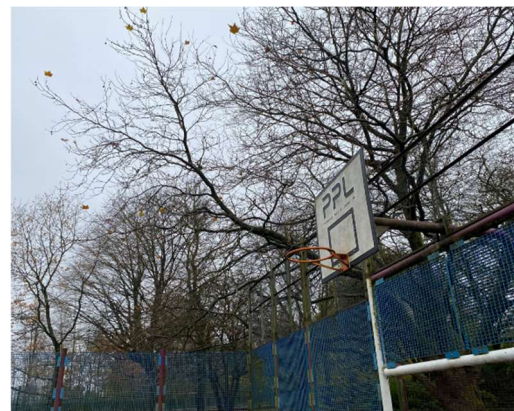
BBCMU02 – Barden Gardens

Tree branch overhanging MUGA fence

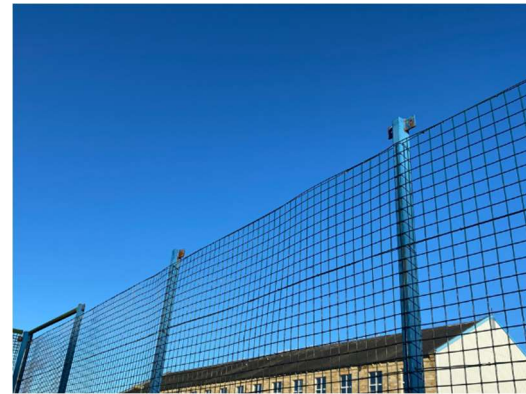
BBCMU04 – Byerden Holme

Top rails on fence missing

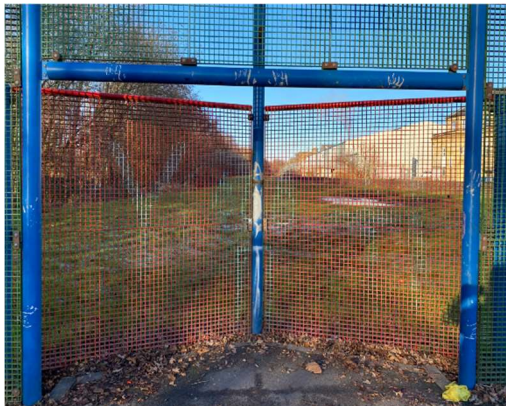
BBCMU04 – Byerden Holme

Scuffs/paint missing on goal posts

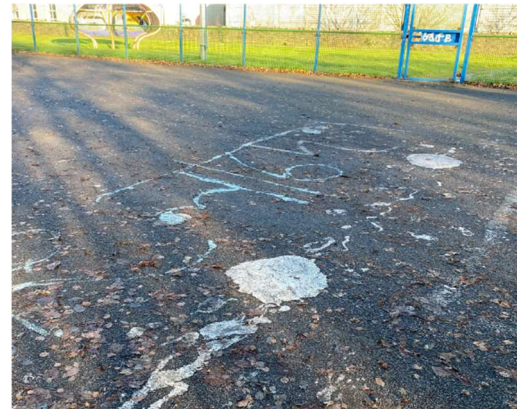
BBCMU04 – Byerden Holme

Paint on MUGA surface

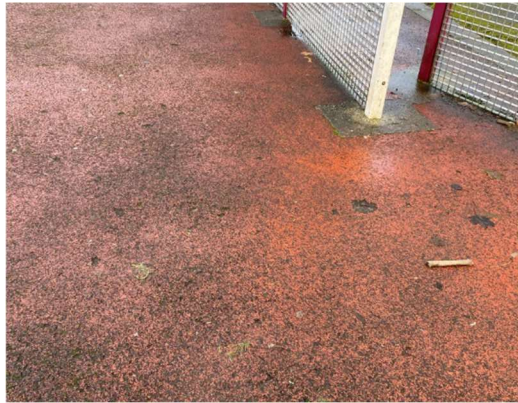
BBCMU05 – Every Street

MUGA surface in poor condition

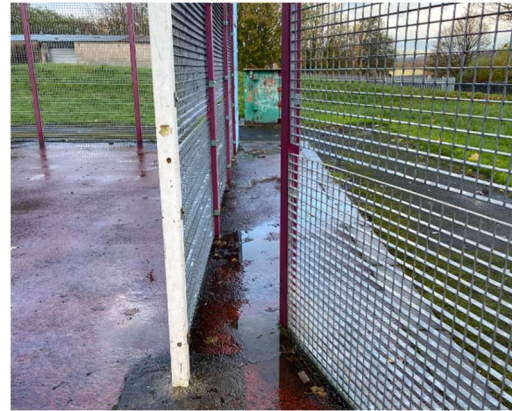
BBCMU05 – Every Street

Narrow surface restricts disabled use

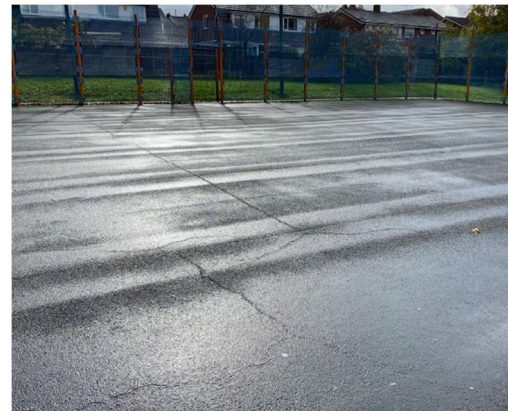
BBCMU06 – Forfar Street

Cracks in MUGA surface

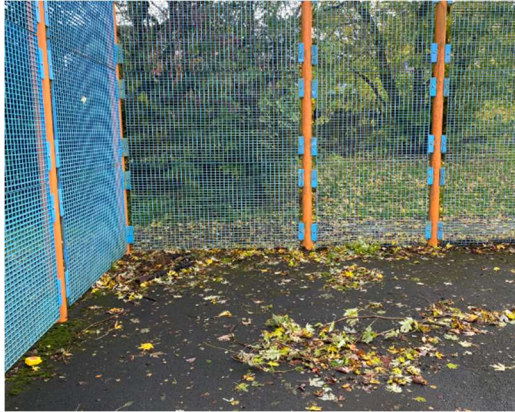
BBCMU06 – Forfar Street

Moss at the corner of the court

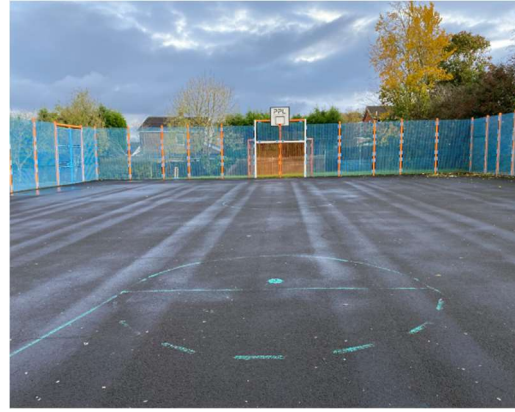
BBCMU06 – Forfar Street

Faded line markings

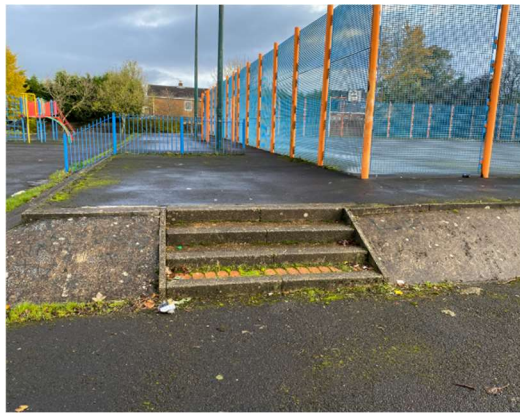
BBCMU06 – Forfar Street

Stepped access restricts disabled users

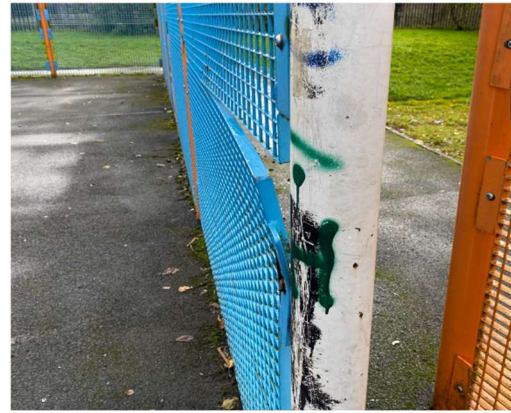
BBCMU06 – Forfar Street

Fence panel bent outwards

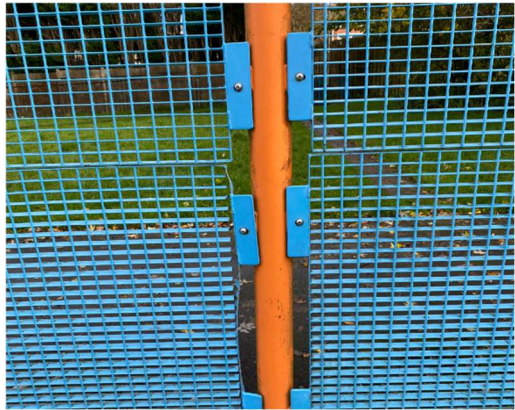
BBCMU06 – Forfar Street

Fence panel detached from fixing

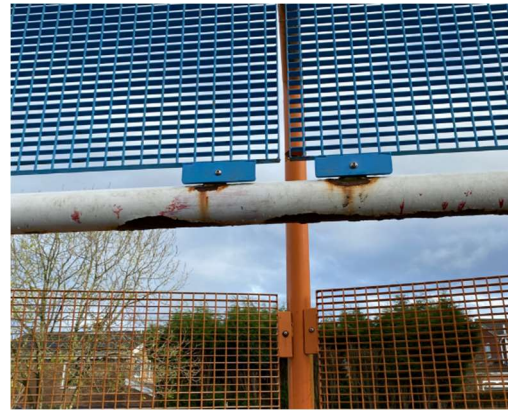
BBCMU06 – Forfar Street

Goal posts have rusted

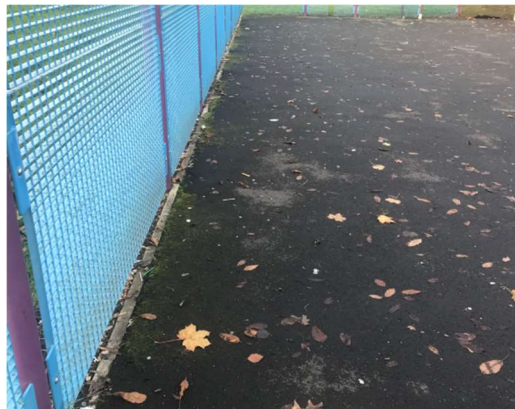
BBCMU07 – Fulledge Recreation Ground

Moss at the edges of the court

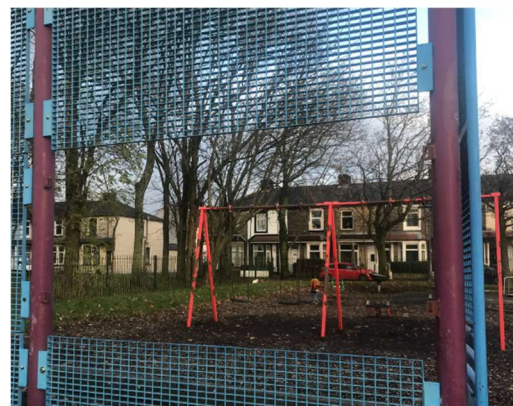
BBCMU07 – Fulledge Recreation Ground

Missing fence panel

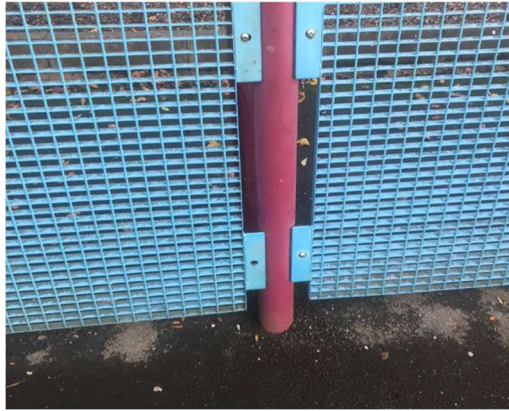
BBCMU07 – Fullede Recreation Ground

5 No. bolts missing from fence panels

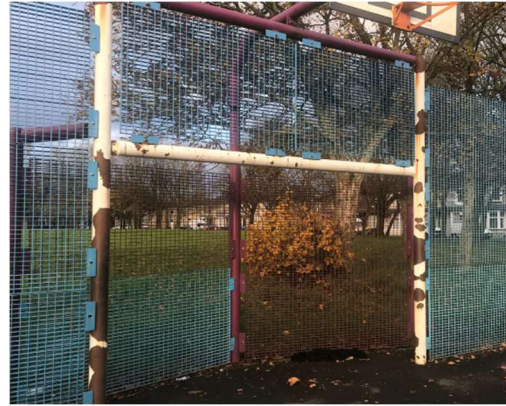
BBCMU07 – Fullede Recreation Ground

Rusted goal posts

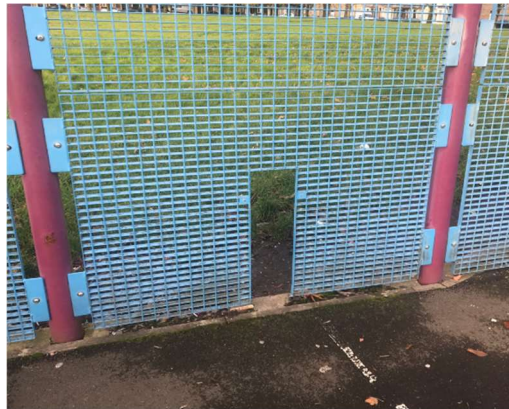
BBCMU07 – Fullede Recreation Ground

Cricket wicket missing from fence

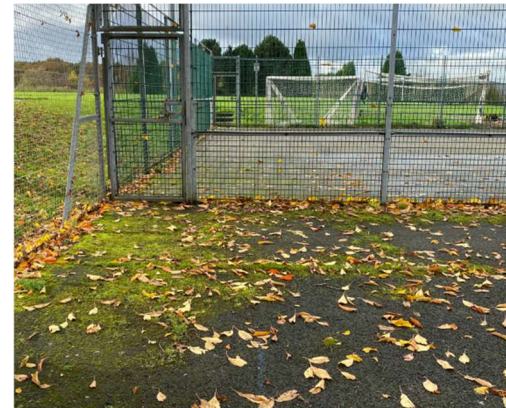
BBCMU08 – Hapton Recreation Ground

MUGA surface in poor condition

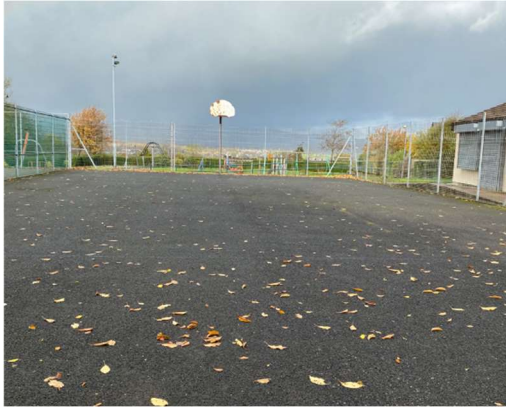
BBCMU08 – Hapton Recreation Ground

Faded line markings

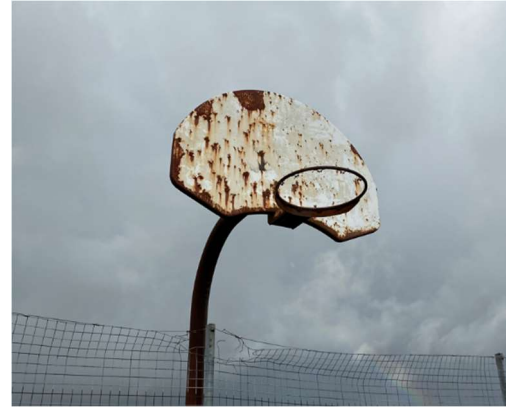
BBCMU08 – Hapton Recreation Ground

Rusted basketball backboards

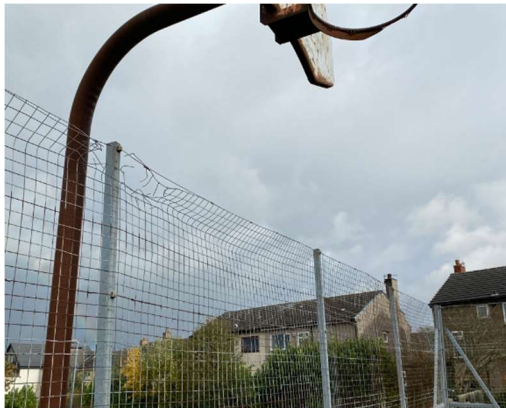
BBCMU08 – Hapton Recreation Ground

Sections of fence in poor condition

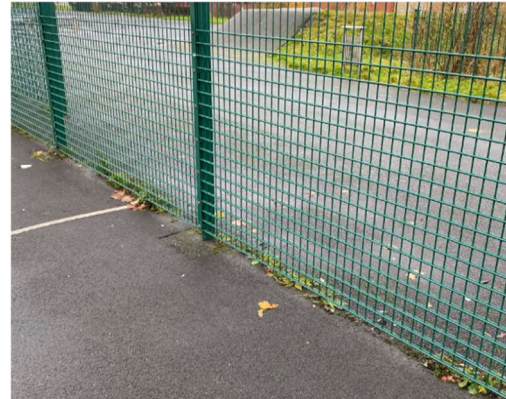
BBCMU09 – Hargher Clough Park

Weeds along fenceline

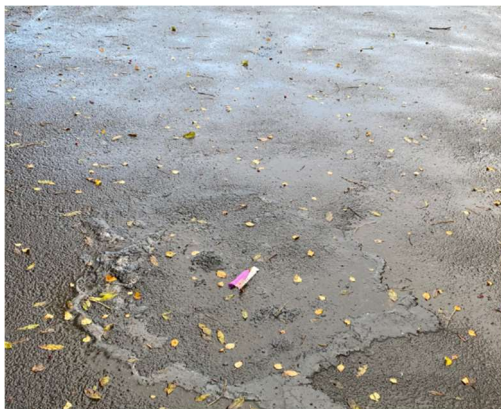
BBCMU10 - Hargrove

Damaged MUGA surface

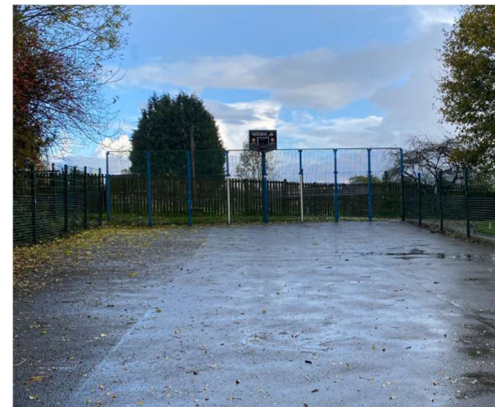
BBCMU10 - Hargrove

Faded line markings

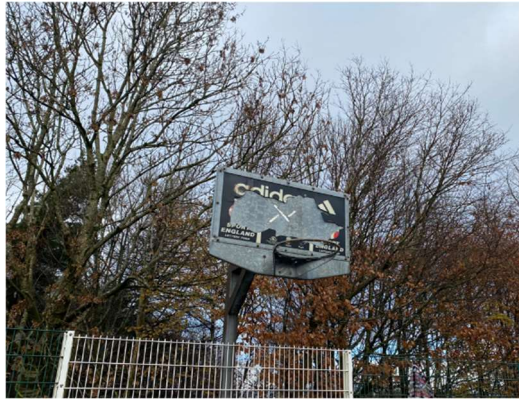
BBCMU11 – Healey Heights

Damaged basketball backboards

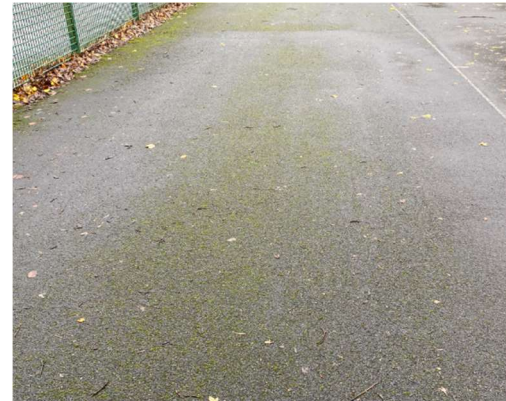
BBCMU12 – Ightenhill Park

Moss on MUGA surface

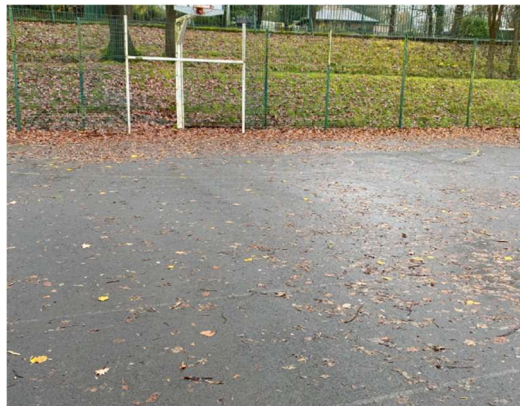
BBCMU12 – Ightenhill Park

Faded line markings

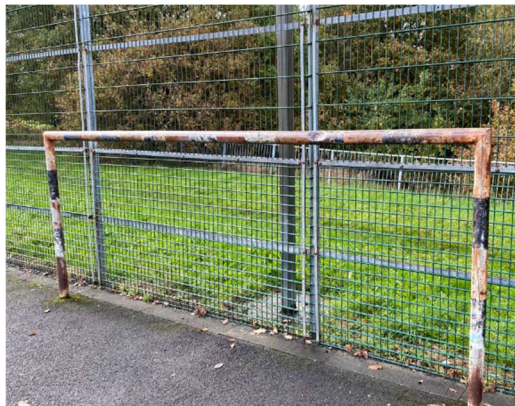
BBCMUI3 – Lancaster Drive

Rusted goal posts

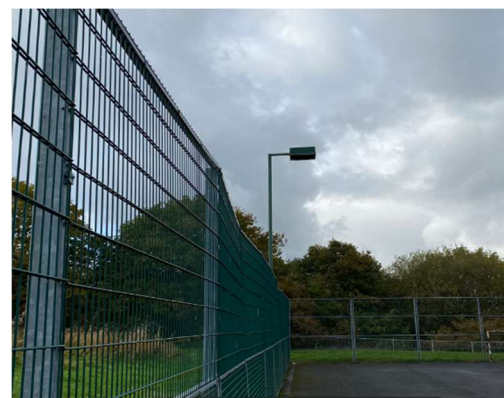
BBCMUI3 – Lancaster Drive

Leaning fence

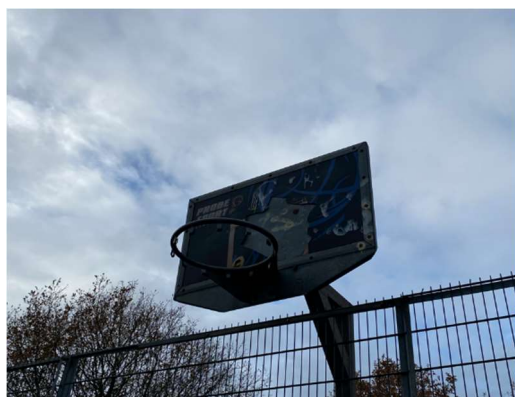
BBCMUI3 – Lancaster Drive

Damaged basketball backboards

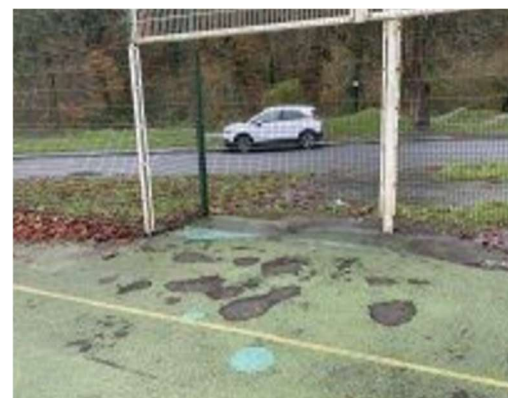
BBCMUI4 – Park Road

MUGA surface in poor condition

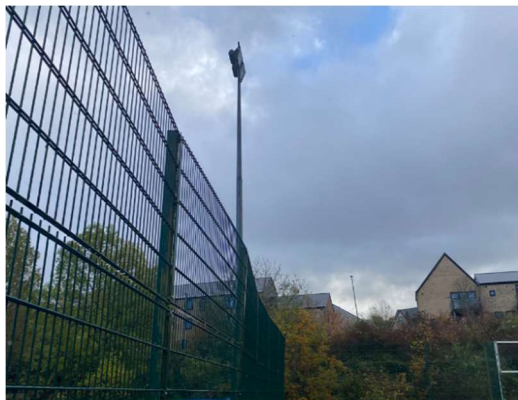
BBCMUI4 – Park Road

Leaning fence

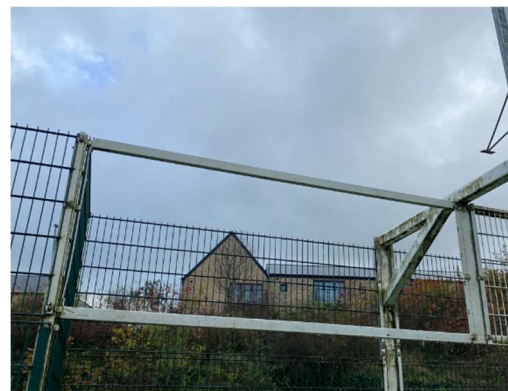
BBCMUI4 – Park Road

Missing fence panel

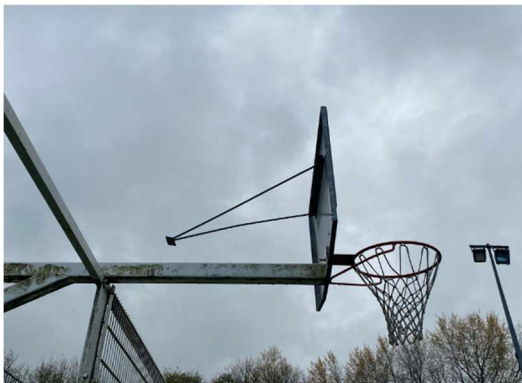
BBCMUI4 – Park Road

Basketball backboard detached from fence

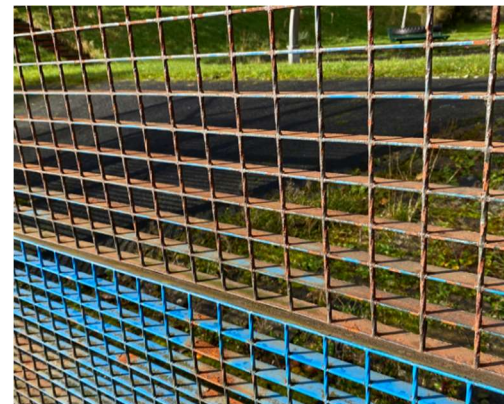
BBCMU15 – Piccadilly Gardens

Fence is rusted

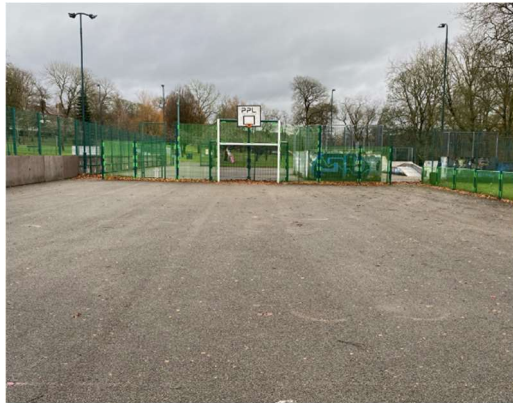
BBCMU16 – Queen’s Park

Faded line markings

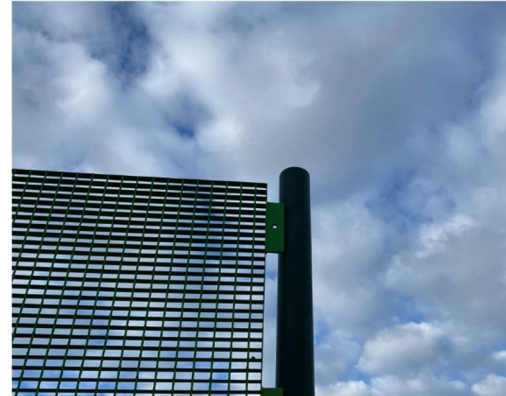
BBCMU16 – Queen’s Park

4 No. bolts missing on fence

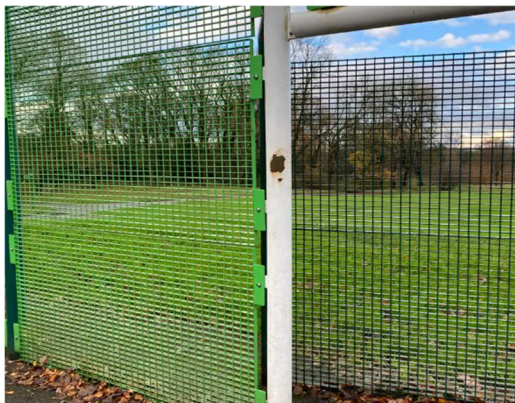
BBCMU16 – Queen’s Park

Rust on goal posts

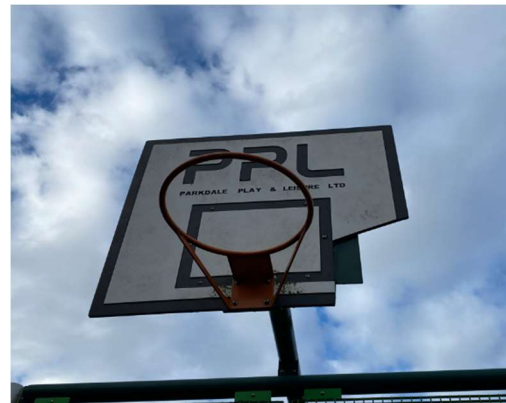
BBCMU16 – Queen’s Park

Damaged basketball backboard

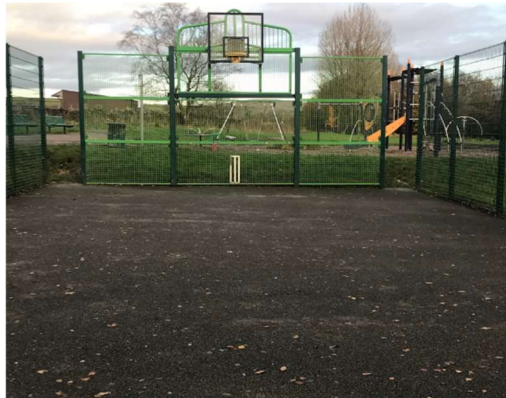
BBCMU17 – Queen Street

Faded line markings

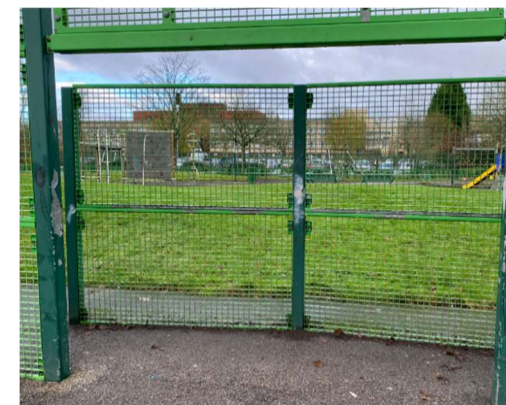
BBCMU18 – Rakehead Recreation Ground

Damaged fence

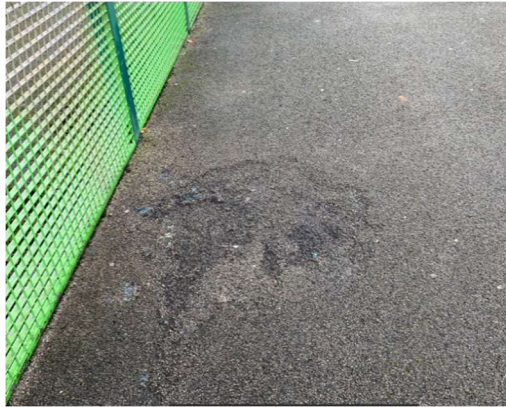
BBCMU18 – Rakehead Recreation Ground

Damaged MUGA surface

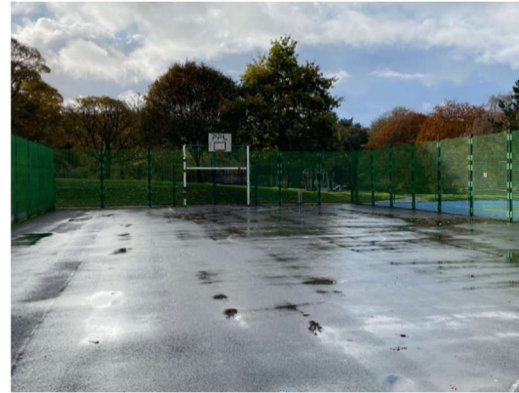
BBCMU19 – Scott Park

MUGA surface holding water

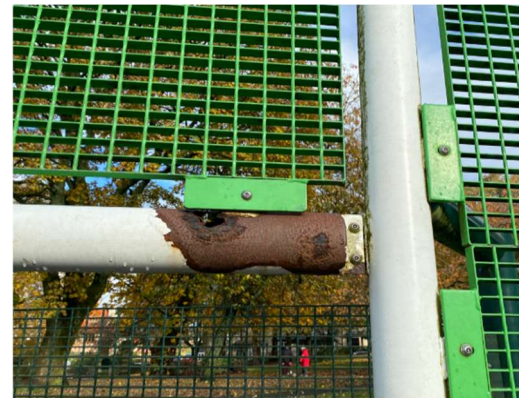
BBCMU19 – Scott Park

Rusted goal post at fixing

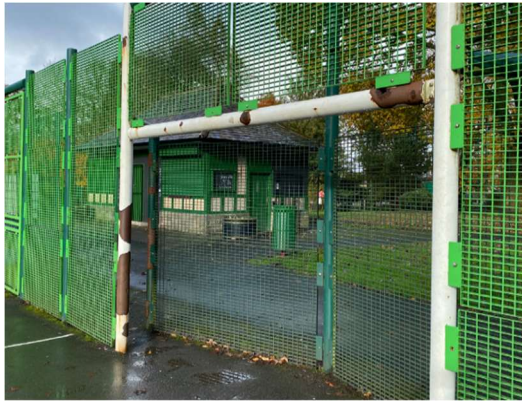
BBCMU19 – Scott Park

Rusted goal post

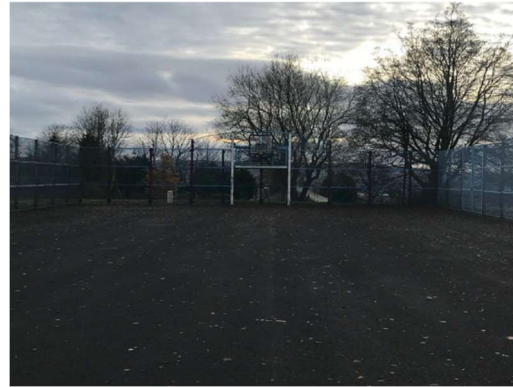
BBCMU20 – Underley Street

Faded line markings

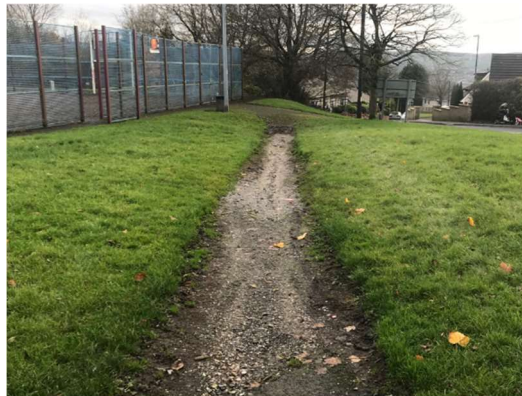
BBCMU20 – Underley Street

Path connection in poor condition

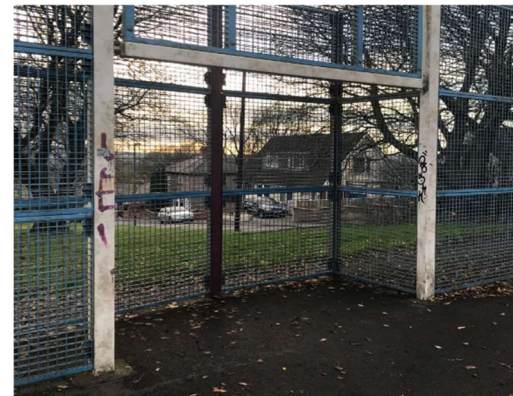
BBCMU20 – Underley Street

Graffitied goal posts

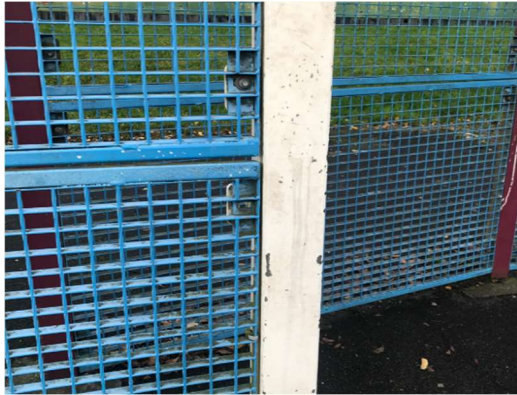
BBCMU20 – Underley Street

Bolt missing in fence

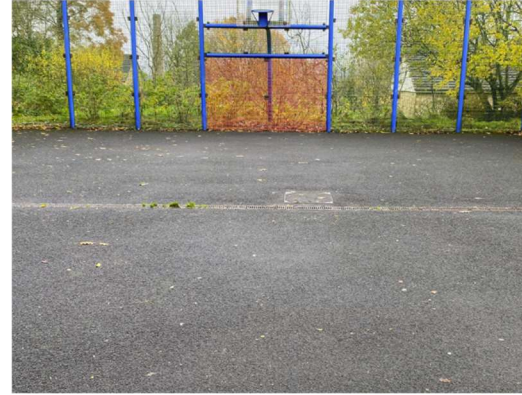
BBCMU21 - Vanguard

Faded line markings

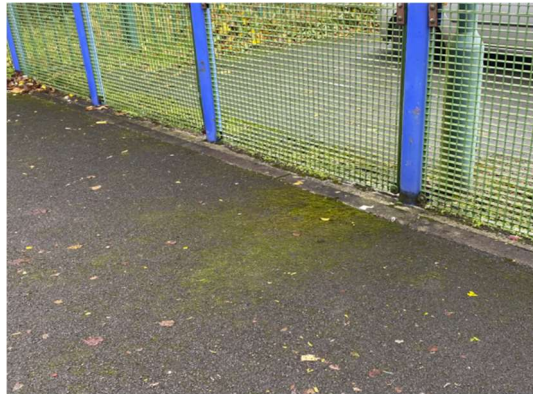
BBCMU21 - Vanguard

Moss on MUGA surface

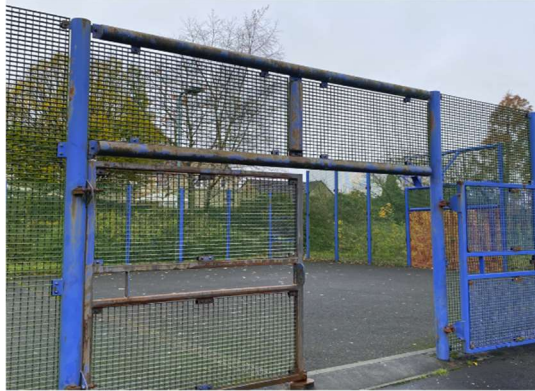
BBCMU21 - Vanguard

Rusted fence

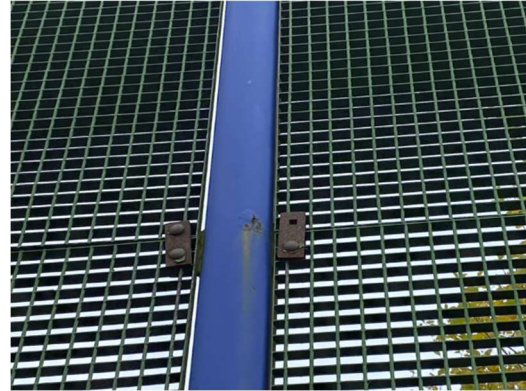
BBCMU21 - Vanguard

2 No. missing bolts in fence

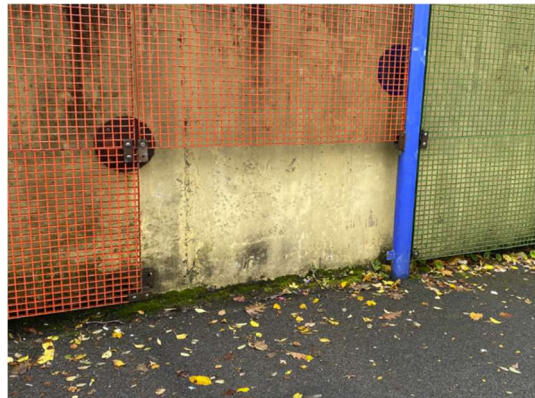
BBCMU21 - Vanguard

Missing fence panel

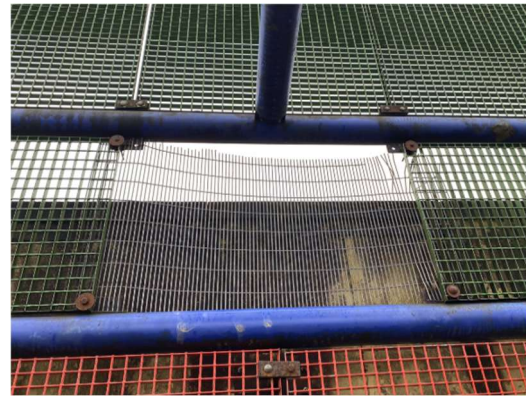
BBCMU21 - Vanguard

Damaged fence panel

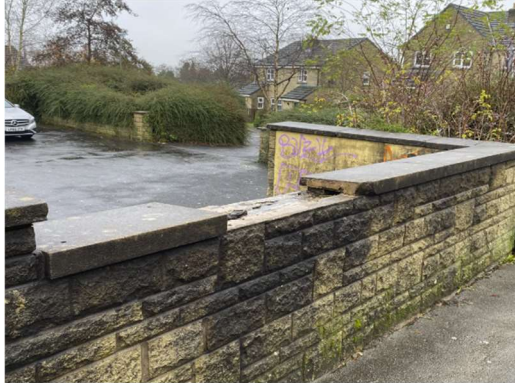
BBCM U21 – Vanguard

Missing coping stone

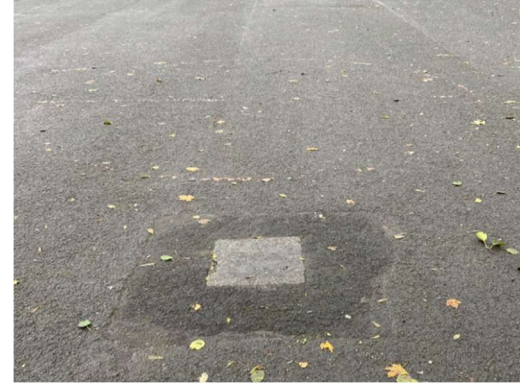
BBCM U21 – Vanguard

MUGA surface in poor condition

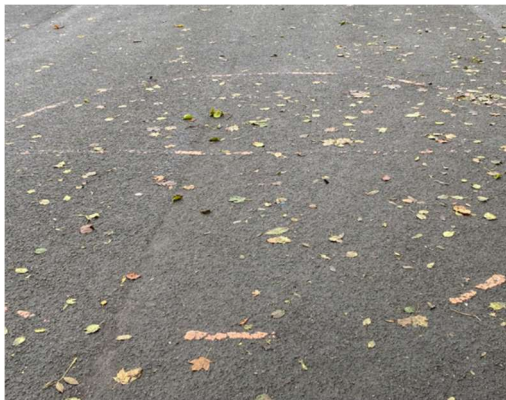
BBCM U21 - Vanguard

Faded line markings

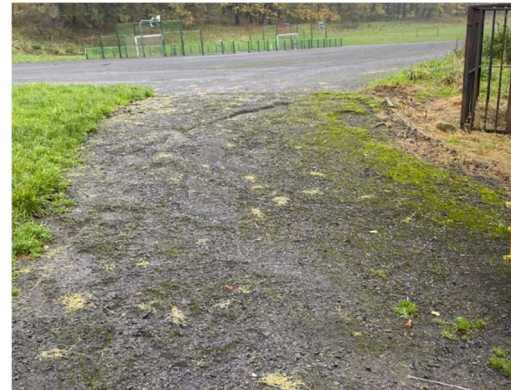
BBCM U22 – Whittlefield Recreation Ground

Footpath connection in poor condition

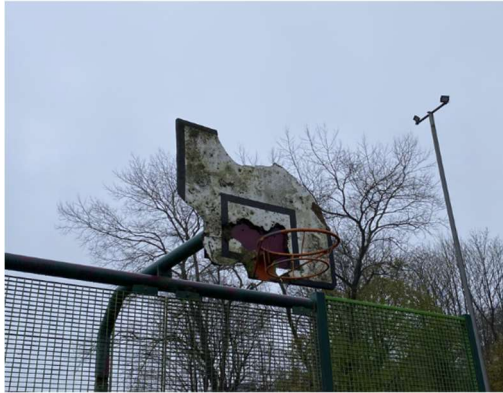
BBCMU22 – Whittlefield Recreation Ground

Damaged basketball backboard

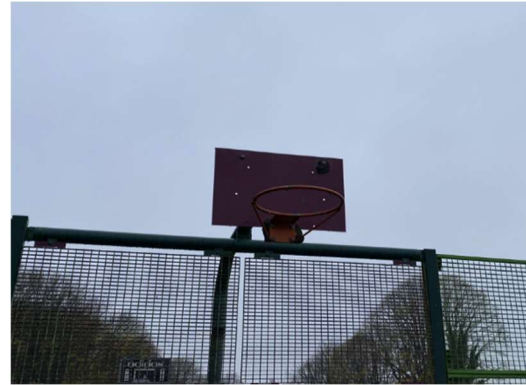
BBCMU22 – Whittlefield Recreation Ground

Damaged basketball backboard

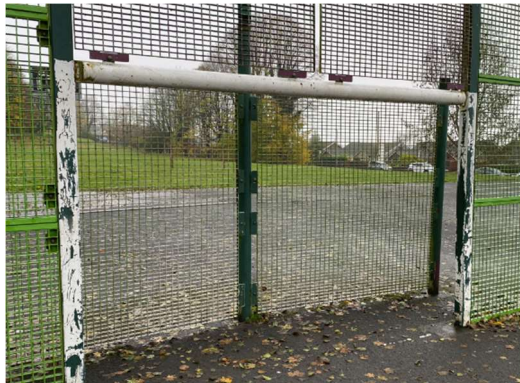
BBCMU22 – Whittlefield Recreation Ground

Rusted/scuffed goal posts
