# MULTI-USE GAMES AREAS (MUGAs)

## 2023/24 CONDITION INSPECTIONS

**VERSION:** 1.4  
**WRITTEN BY:** Neil Yates  
**IMPLEMENTED:** 13<sup>th</sup> Dec 2023

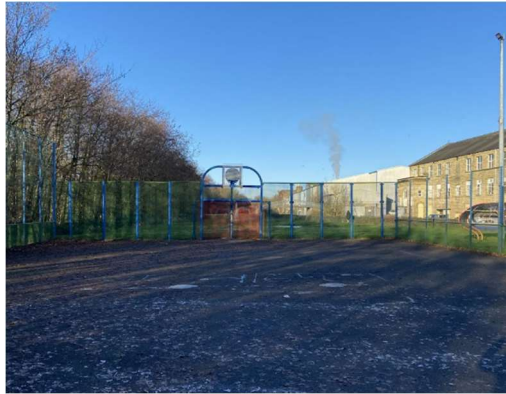
BBCMU04 – Byerden Holme

Faded line markings

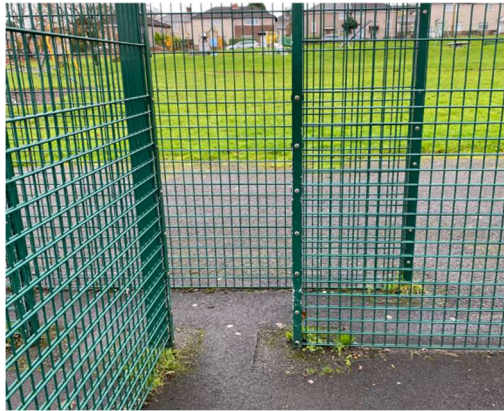
BBCMU09 – Hargher Clough Park

Narrow access restricts disabled use

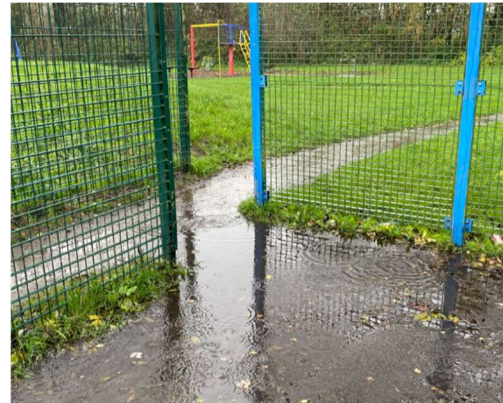
BBCMU10 - Hargrove

Weeds along fenceline

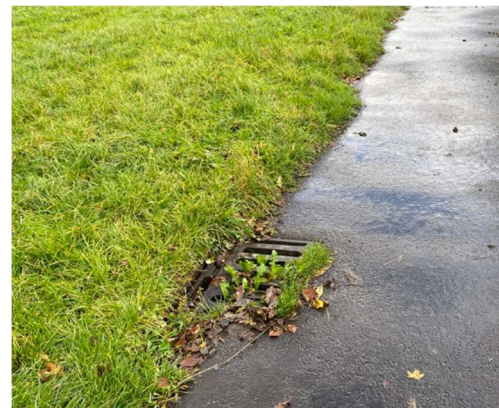
BBCMU11 – Healey Heights

2 No. blocked gullies

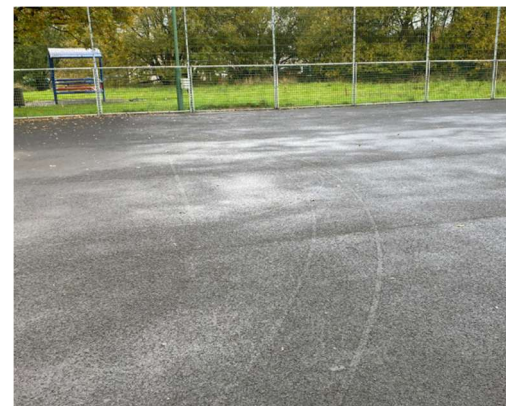
BBCMU13 – Lancaster Drive

Faded line markings

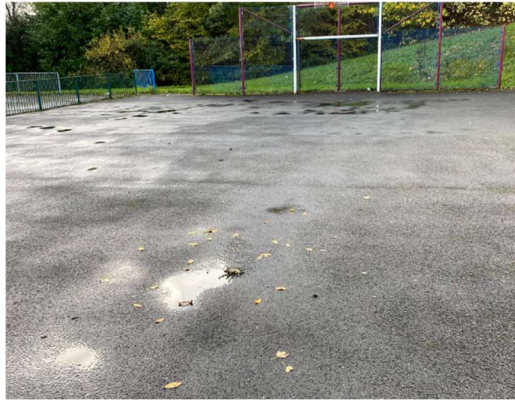
BBCMU15 – Piccadilly Gardens

Faded line markings

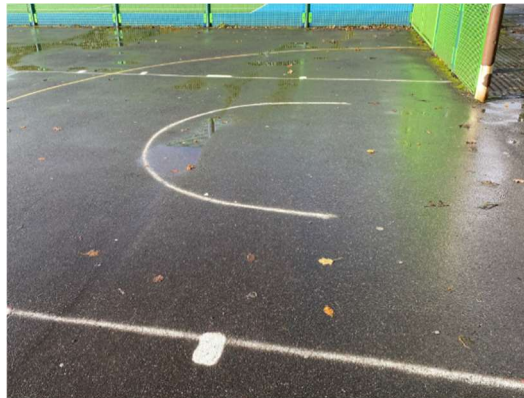
BBCMU19 – Scott Park

Line markings starting to fade

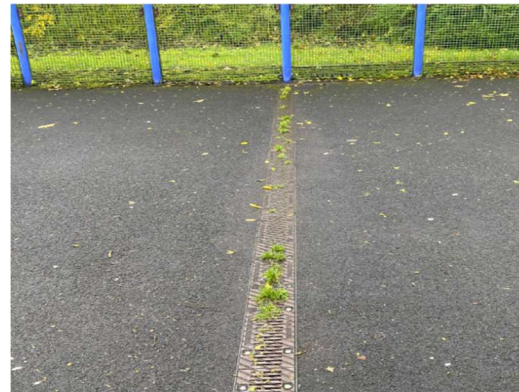
BBCMU21 - Vanguard

Blocked ACO drain
