# MULTI-USE GAMES AREAS (MUGAs)

## 2023/24 CONDITION INSPECTIONS

**VERSION:** 1.4  
**WRITTEN BY:** Neil Yates  
**IMPLEMENTED:** 13<sup>th</sup> Dec 2023

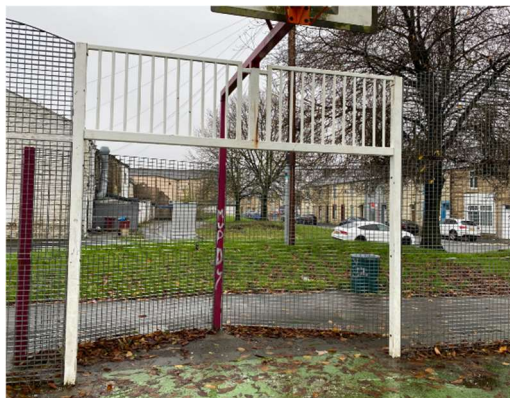
BBCMU01 – Abel Street

Graffitied/faded paint on goal posts

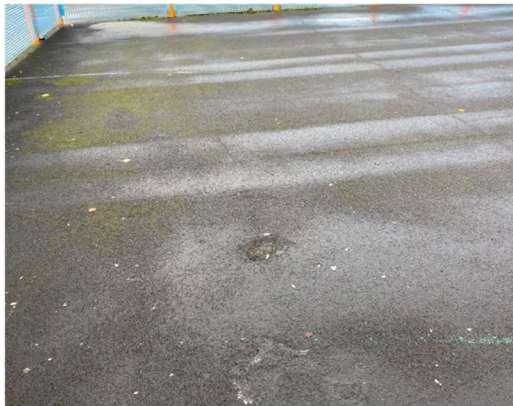
BBCMU06 – Forfar Street

Pothole near goal mouth

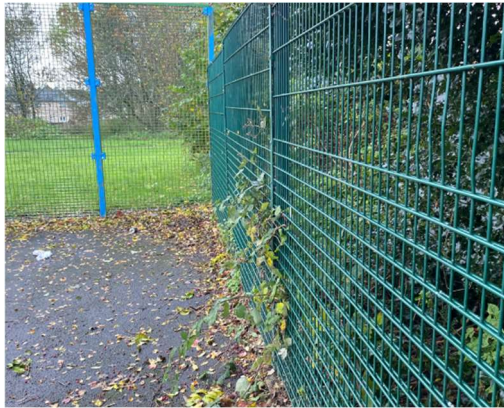
BBCMU10 - Hargrove

Vegetation growing through fence

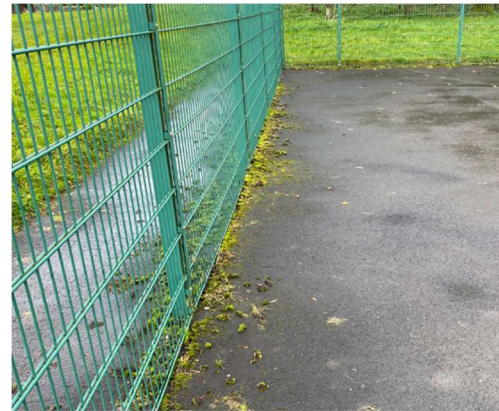
BBCMU11 – Healey Heights

Moss on surface at edge of court

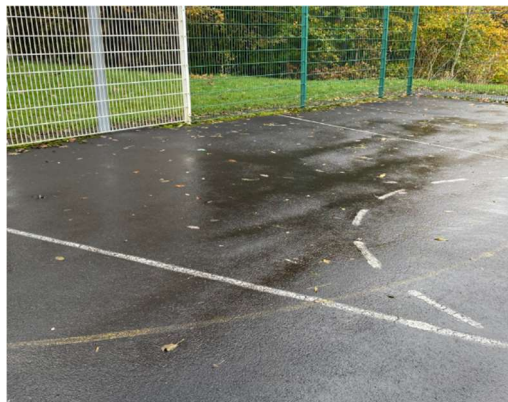
BBCMU11 – Healey Heights

Faded line markings

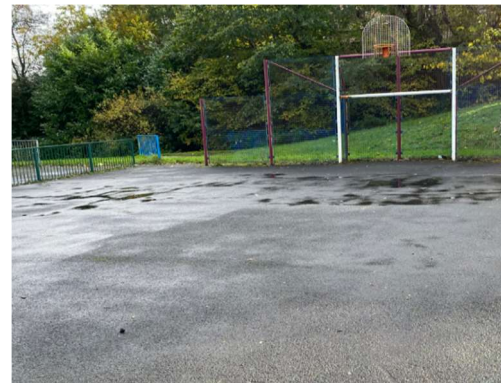
BBCMUI5 – Piccadilly Gardens

MUGA surface holding water

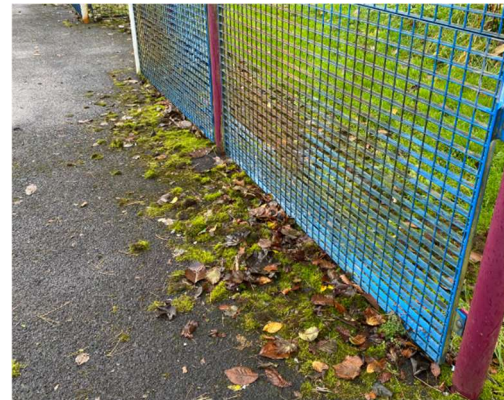
BBCMU15 – Piccadilly Gardens

Moss grown on MUGA surface

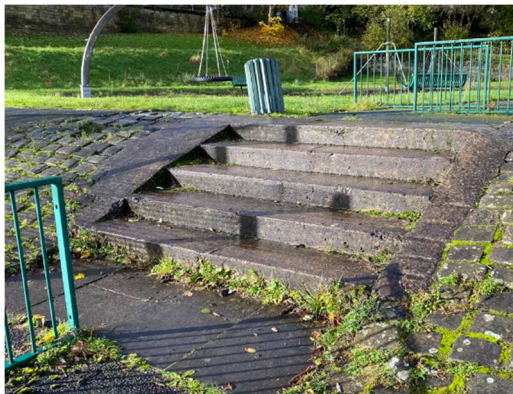
BBCMU15 – Piccadilly Gardens

Steps restrict disabled access

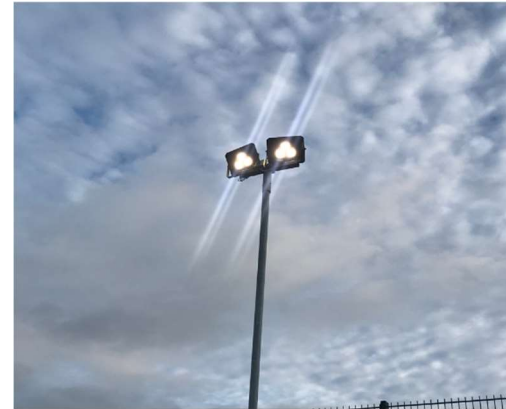
BBCMU17 – Queen Street

Floodlight lit in daylight

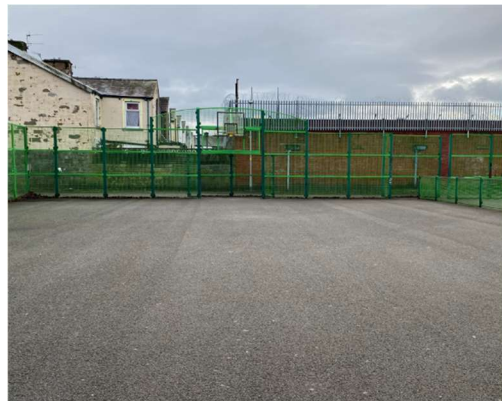
BBCMU18 – Rakehead Recreation Ground

Faded line markings
